INDOOR AIR QUALITY ASSESSMENT

**Cambridge Peabody Elementary School
44 Linnaean Street
Cambridge, Massachusetts**

Prepared by:
Massachusetts Department of Public Health
Bureau of Environmental Health Assessment
Emergency Response/Indoor Air Quality Program
October 2003

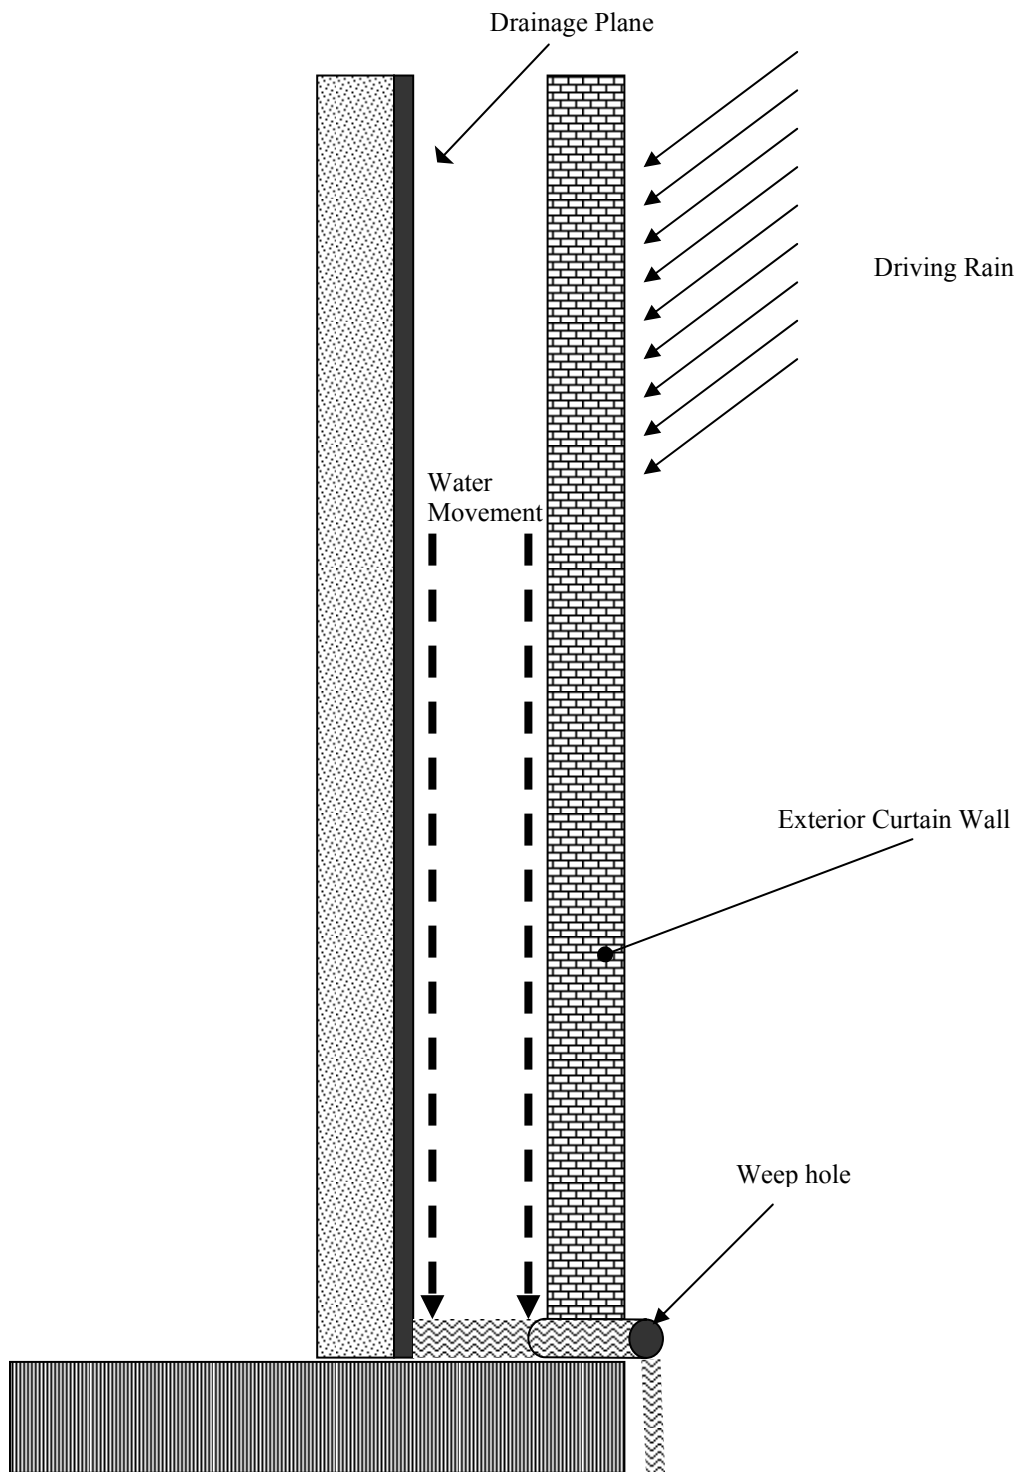
Figure 2
The Function of the Drainage Plane and Weep Holes to Drain Water from the Wall System, Prevent Moisture Penetration into the Interior

Also of interest are the weep holes along the base of the courtyard brick walls. Weep holes were systematically sealed to prevent rodent infiltration (Picture 10). In order to allow for water to drain from the exterior brick wall system, a series of weep holes is customarily installed at or near the foundation slab/exterior wall system junction (Figure 2). Weep holes allow for accumulated water to drain from a wall system (Dalzell, 1955). Failure to install weep holes in brickwork or burial of weep holes below grade can allow water to accumulate in the base of walls, resulting in seepage and possible moistening of building components (Figure 3). While sealed weep holes may prevent rodent infestation, the sealing could also result in water infiltration.

16. Seal/replace caulking around univent fresh air intakes and wall panels on the exterior of the building.
17. Consider consulting a structural engineer/architect specializing in building envelope issues to examine the drainage plane and the blockage of weep holes in the courtyard.

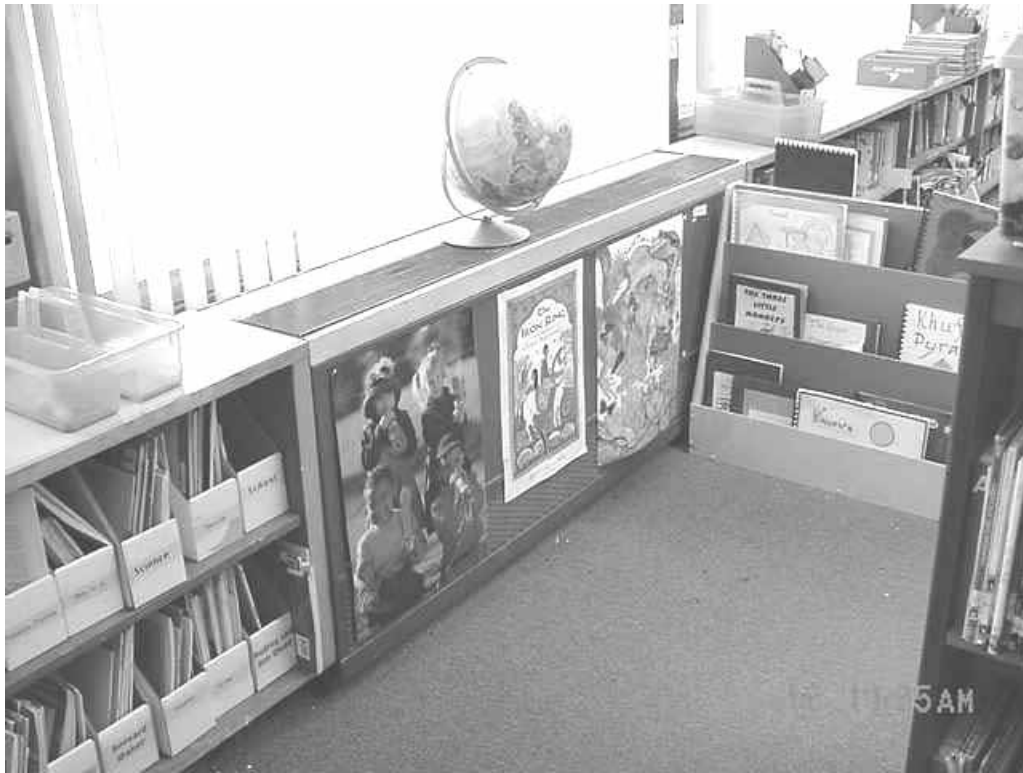
Picture 1

Fresh air in classrooms is supplied by a unit ventilator (univent) system ([Picture 1](#)). Univents draw air from outdoors through a fresh air intake located on the exterior walls of the building (Picture 2) and return air through an air intake located at the base of each unit (Figure 1). Fresh and return air are mixed, filtered, heated and provided to classrooms through a fresh air diffuser located in the top of the unit. Obstructions to airflow, such as papers and books stored on univents and bookcases and/or carts and desks located in front of univent returns, were seen in a number of classrooms (Picture 1). Univents were found deactivated in classrooms throughout the school. In order for univents to provide fresh air as designed, intakes must remain free of obstructions; importantly these units must remain “on” and allowed to operate while rooms are occupied.

Classroom Unit Ventilator (Univent)

3. Examine each univent for function. Survey classrooms for univent function to ascertain if an adequate air supply exists for each room. Consider consulting a heating, ventilation and air conditioning (HVAC) engineer concerning the calibration of univent fresh air control dampers throughout the school.

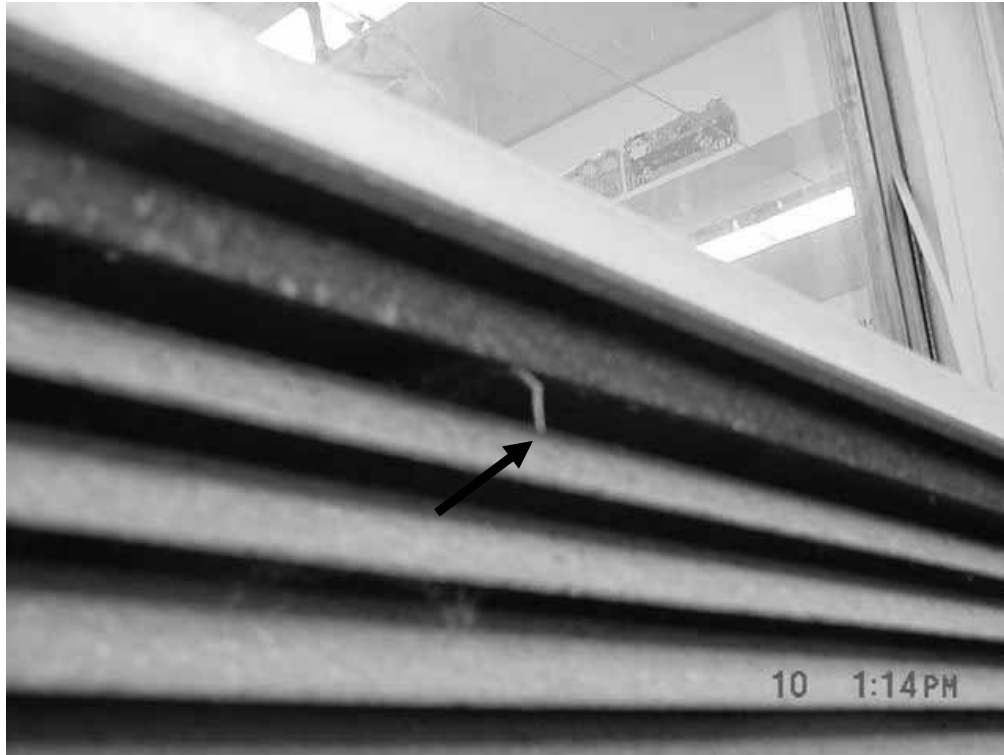
CPS officials reported that the building has had problems with mice. During a perimeter inspection of the courtyard Mr. Ginieres identified a decaying mouse on/about the fresh air intake (Picture 2). No odors associated with decaying organic material were detected during the assessment or reported by occupants of this classroom. As a result of materials present in

Univent Fresh Air Intake, Note Mouse Tail Hanging out of Intake Grill

2. Ensure univent fresh air intakes are free of mouse carcasses. Clean and disinfect univent fresh air intake in Picture 2 with an appropriate antimicrobial.

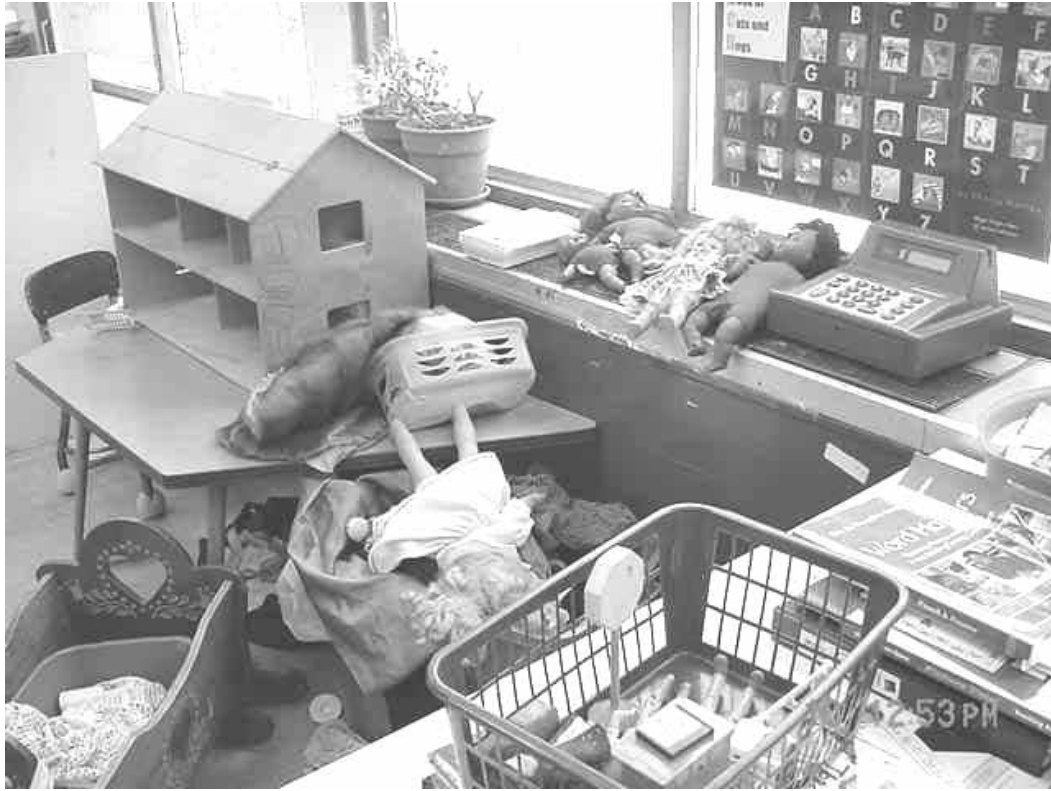
Picture 3

Various Items on and in front of Classroom Univent Obstructing Airflow

7. Remove all blockages from univents and exhaust vents to ensure adequate airflow.
8. Ensure coat closet doors are closed to allow exhaust vents to operate.

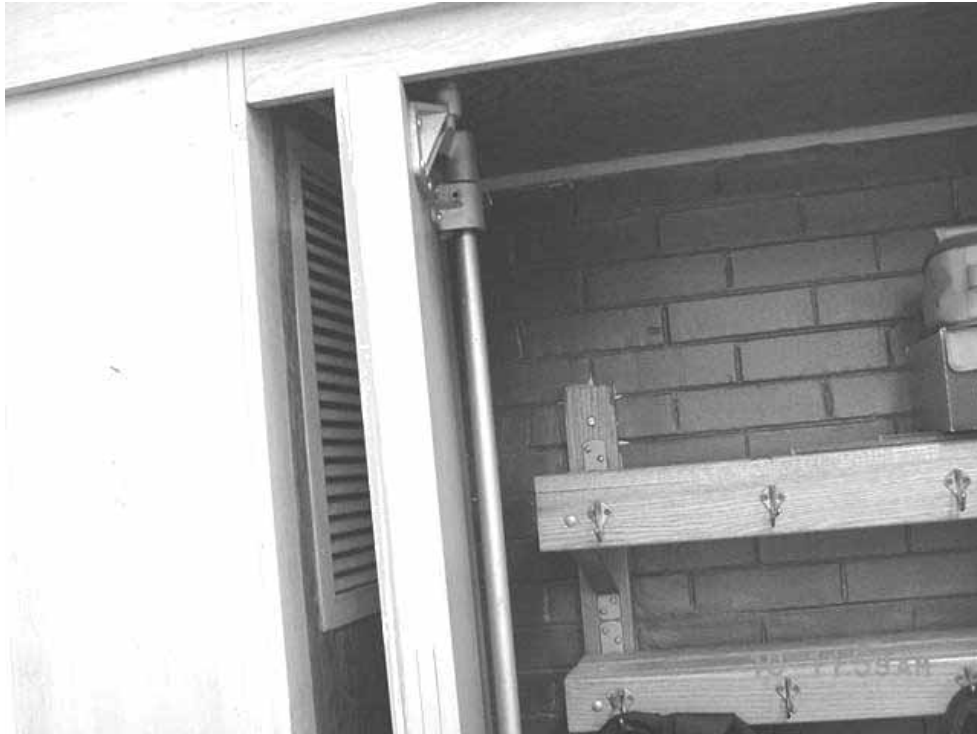
Picture 4

Exhaust vents in classrooms are located in the upper interior wall of coat closets (Picture 4). Classroom air is drawn into the coat closet via the undercut portion of the closet door (Picture 5). The location of the exhaust vents allows easy vent blockage by stored materials. In a number of classrooms, these vents were blocked with books, backpacks, boxes and, in particular, open closet doors. In addition, when coat closet doors remain open, they obstruct airflow into the vent (Picture 4). In order to function properly, these vents must remain free of obstructions.

Exhaust Vent on Interior Wall of Coat Closet, Note how Vent is Blocked When Closet Door is Open

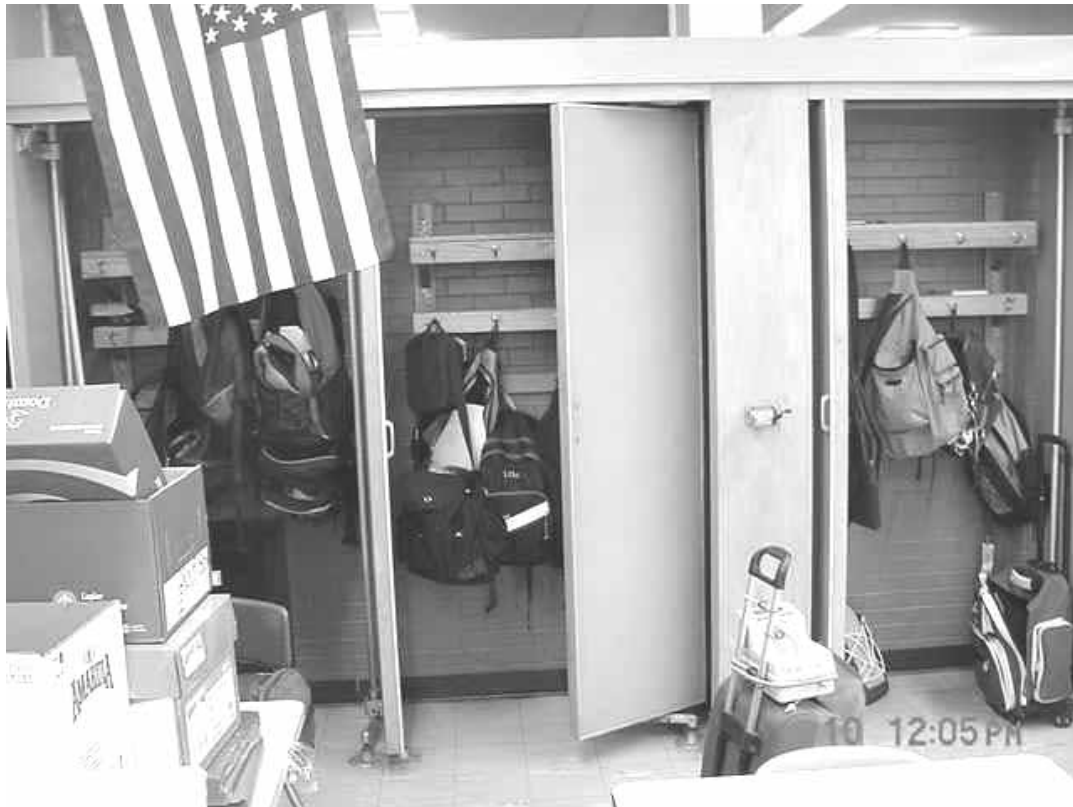
Picture 5

Classroom Coat Closets and Undercut Doors

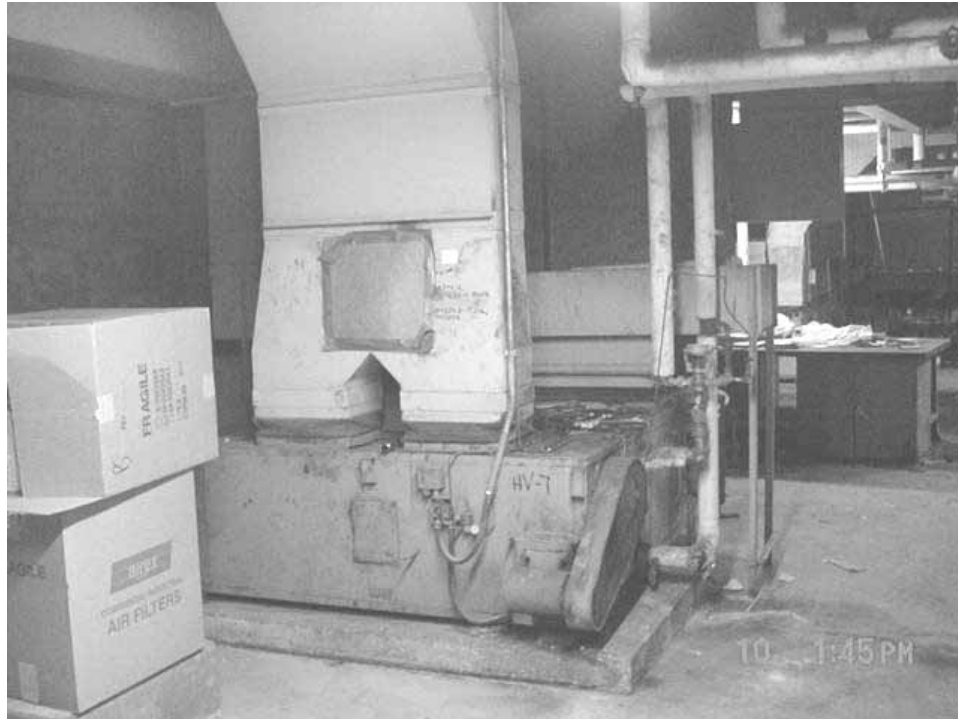
Picture 6

As previously mentioned, several air handling units (AHUs) for common areas are located in the boiler room. Ductwork connected to AHUs in the boiler room was not airtight and had breaches around seams and joints. In one instance, a ductwork panel was being held in place by duct tape (Picture 6). These breaches can provide a source of boiler room odors and a source for particulate matter to be entrained by the ventilation system and subsequently distributed by the AHUs.

AHU Located in Boiler Room, Note Panel with Duct Tape

12. Determine and remediate source of leakage in the boiler room.
13. Discard water damaged/mold colonized materials.
14. Seal all seams/breaches in ductwork on AHUs in the boiler room.

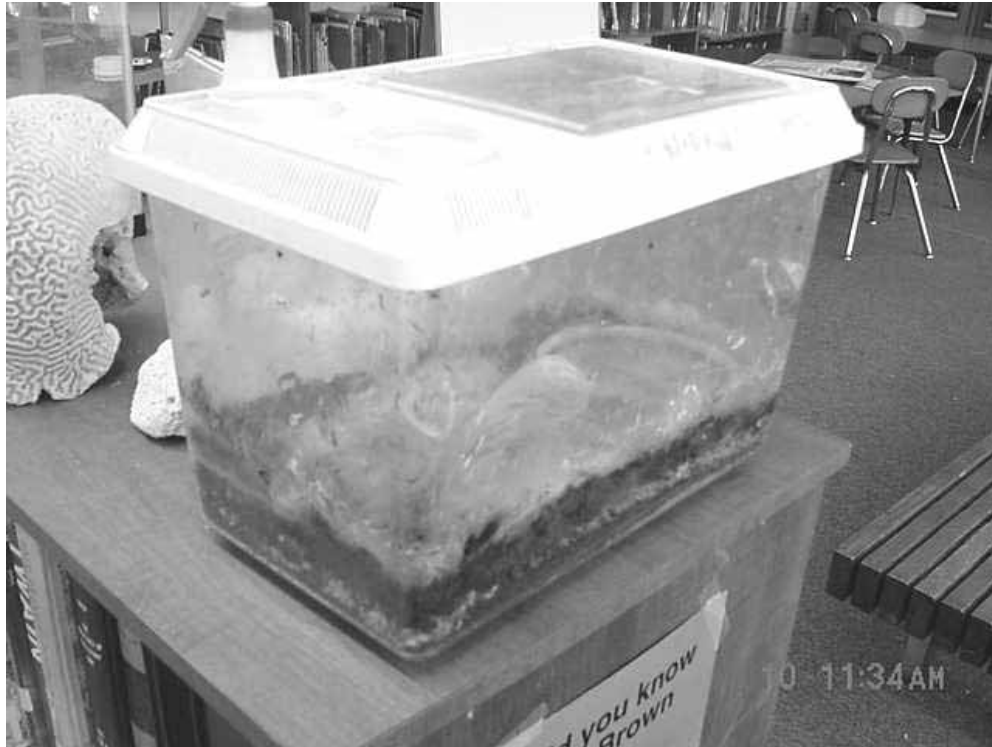
Picture 7

of which had rotting food and/or visible mold growth (Picture 7). Aquariums and terrariums should be properly maintained and cleaned to prevent bacterial growth, mold growth, and nuisance odors.

Terrarium with Rotting Food/Mold Growth in Library

19. Remove plants growing against the exterior wall/foundation of the building to prevent water penetration. Trim trees away from brickwork.
20. Clean and maintain aquariums and terrariums to prevent bacterial/mold growth.

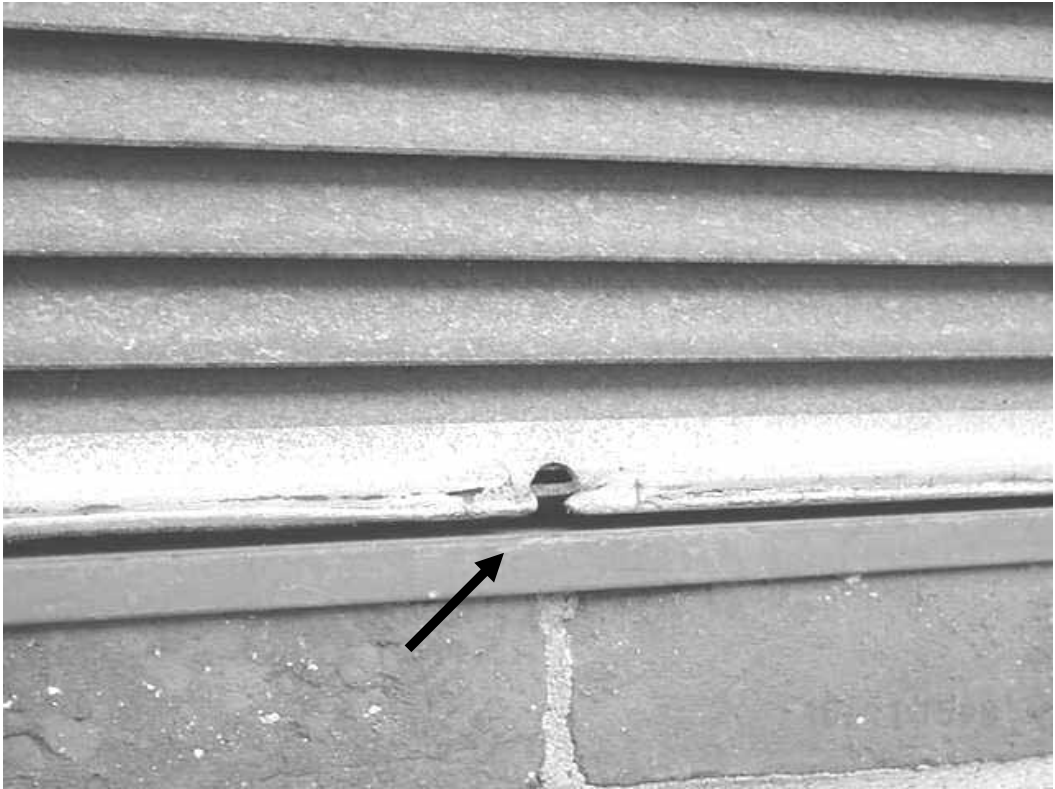
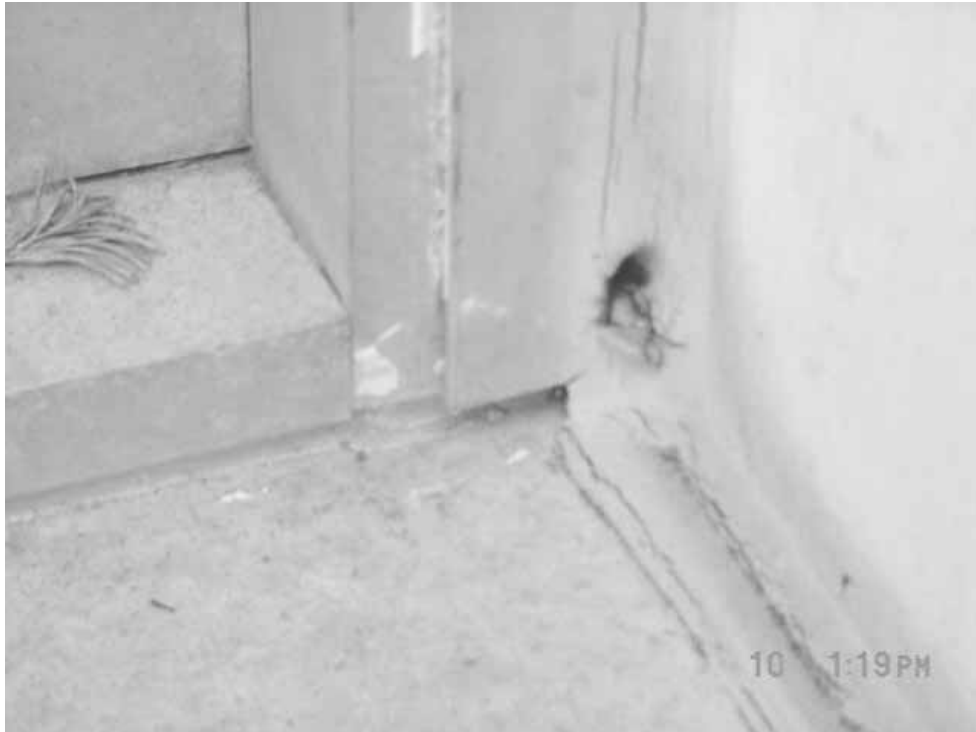
Exterior caulking around wall panels and univent air intakes on the exterior of the building was crumbling/damaged in a number of areas indicating that the seal is no longer intact (Pictures 8 & 9). These breaches in the building envelope can provide a means of water penetration. Large wall cracks may also provide a means of egress for pests/rodents into the building.

Spaces around Univent Fresh Air Intake

Hole in Caulking Exterior Wall Panel Courtyard

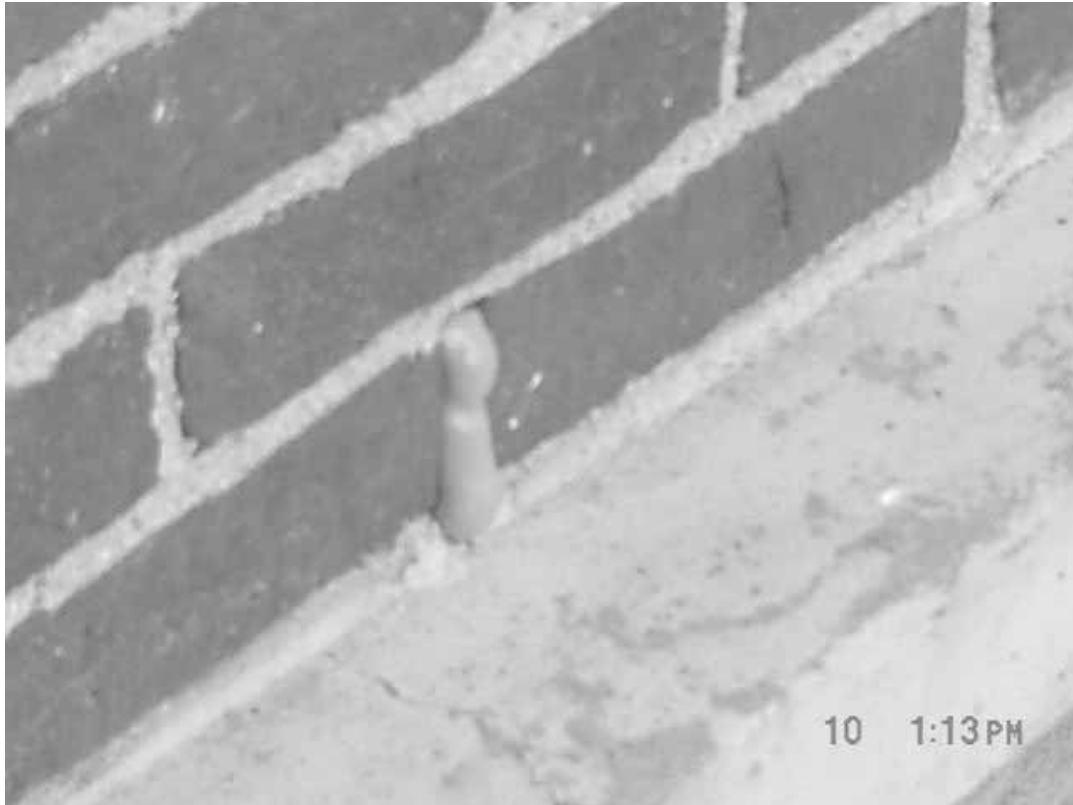
Picture 10

Sealing of Weep-Holes in Brick Walls of Courtyard

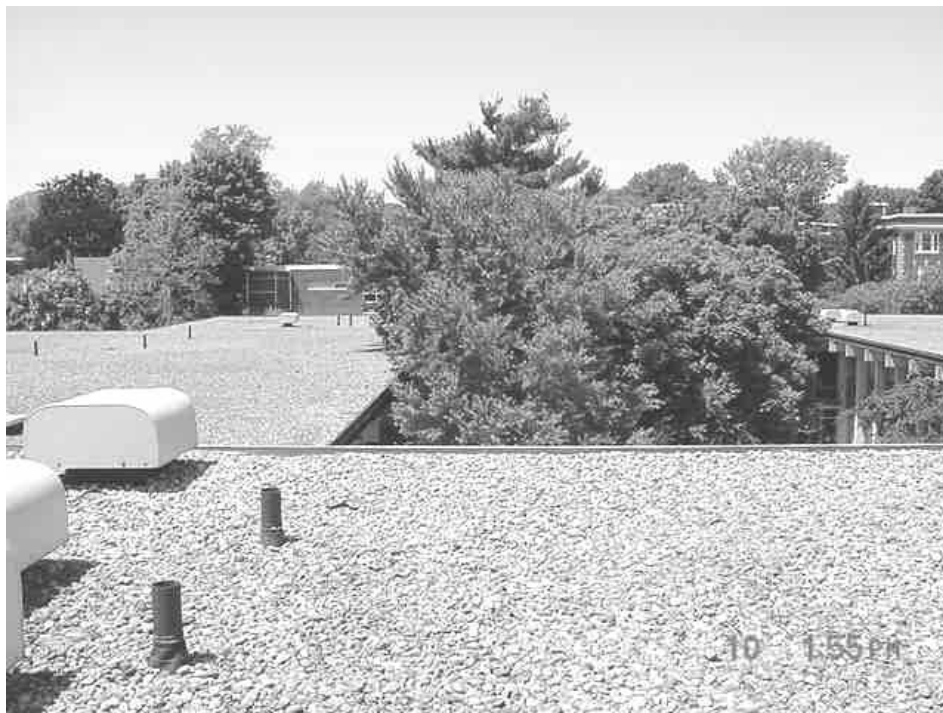
Picture 11

Trees and other plants were also seen growing in the tarmac/exterior wall junction (Picture 11). The growth of roots against the exterior of foundation, as well as spaces between

the tarmac, can bring moisture in contact with brick and foundation walls, which may eventually lead to moisture penetration below ground.

Tree in Courtyard in Close Proximity to Exterior Walls

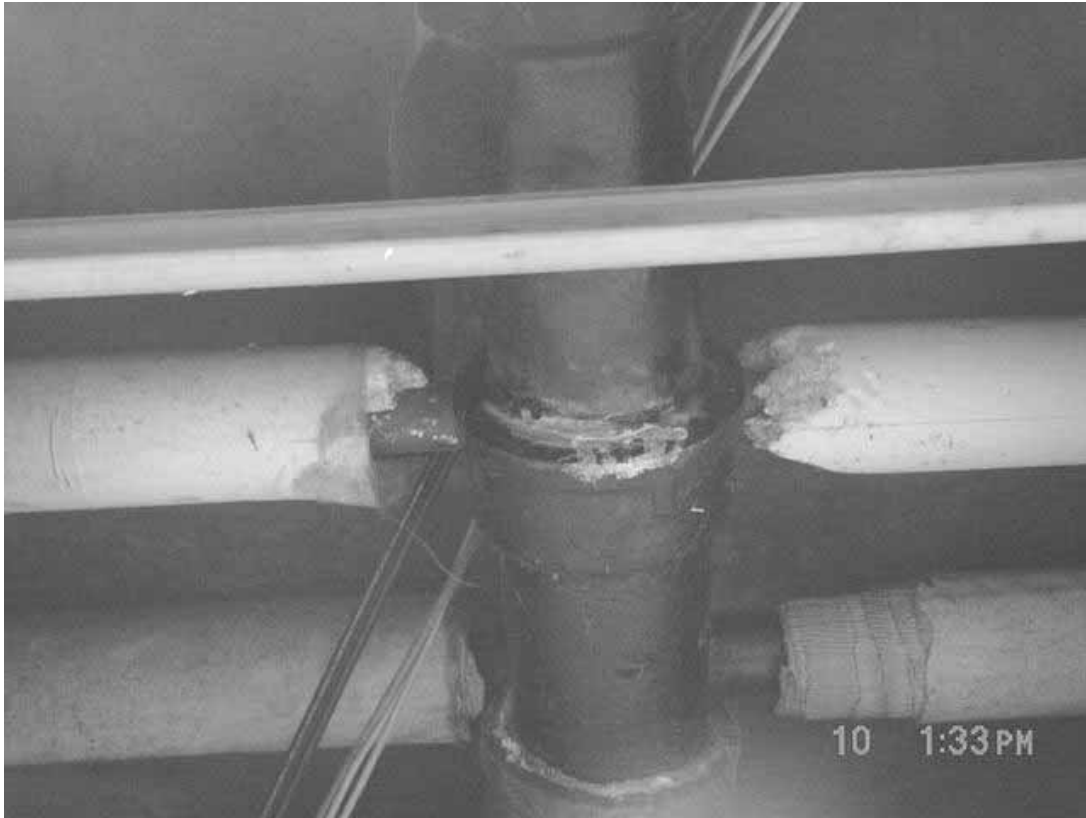
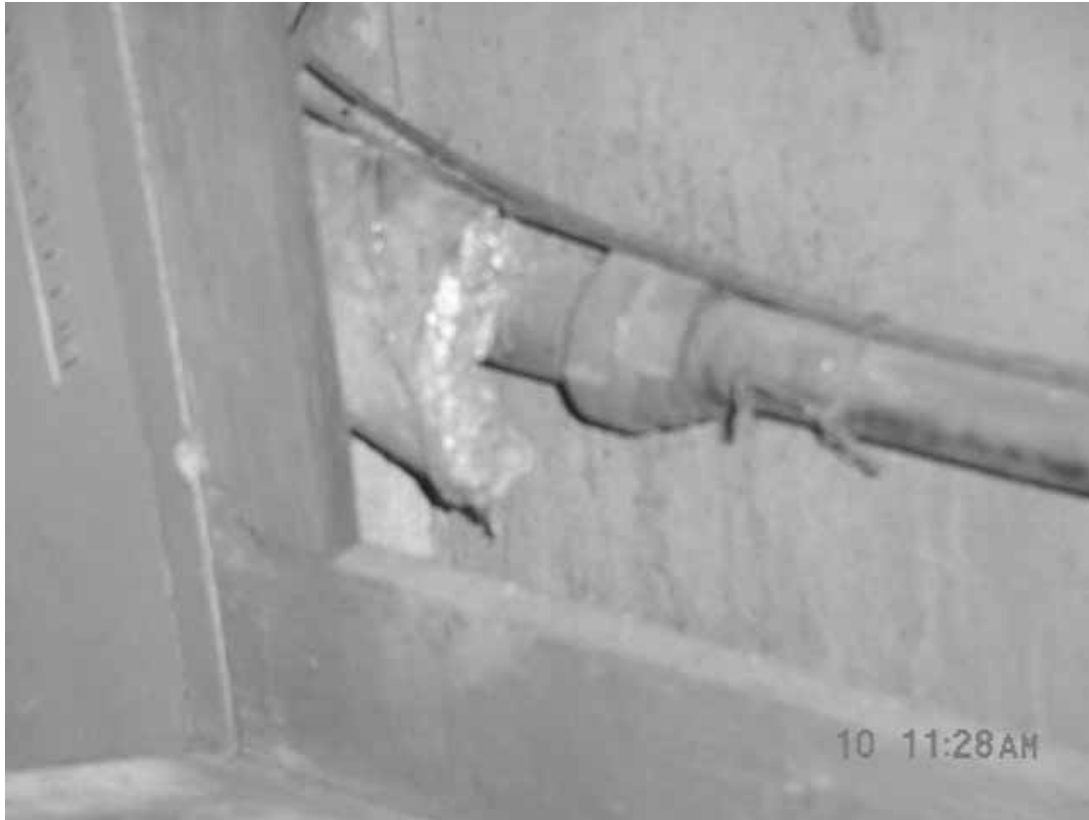
Several other conditions that can potentially affect indoor air quality were identified. Damaged pipe insulation was observed behind a loose wall panel in classroom 18 and on an overhead pipe in the art room (Pictures 12 & 13). The pipe insulation may contain asbestos. Upon discovery, these findings were reported to Mr. Lombardo. BEHA staff recommended that the material be encapsulated by a licensed member of the Cambridge Public Schools maintenance staff or other professional contractor as soon as practicable.

Damaged/Exposed Pipe Insulation in Art Room

Damaged/Exposed Pipe Insulation in Room 18

1. Ensure exposed/damaged pipe insulation material in classroom 18 and art room is encapsulated/remediated in conformance with all applicable Massachusetts' laws.

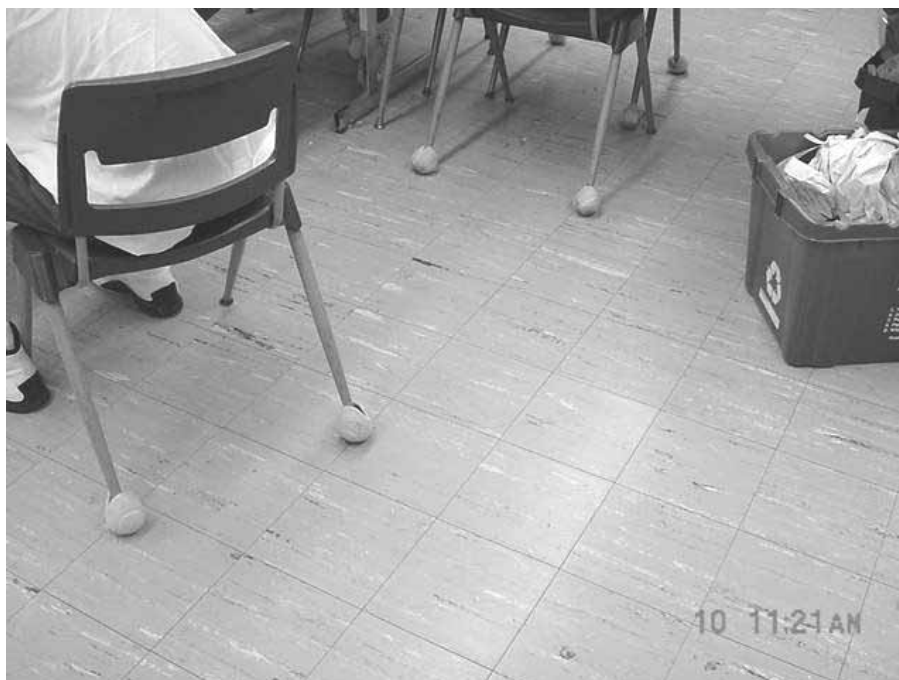
Picture 14

In an effort to reduce noise from sliding chairs, tennis balls had been sliced open and placed on chair legs (Picture 14). Tennis balls are made of a number of materials that are a source of respiratory irritants. Constant wearing of tennis balls can produce fibers and lead to off-gassing of VOCs. Tennis balls are made with a natural rubber latex bladder, which becomes abraded when used as a chair leg pad. Use of tennis balls in this manner may introduce latex dust into the school environment. Some individuals are highly allergic to latex (e.g., spina bifida patients) (SBAA, 2001). It is recommended that the use of materials containing latex be limited in buildings to reduce the likelihood of symptoms in sensitive individuals (NIOSH, 1997). A question and answer sheet concerning latex allergy is attached as [Appendix II](#) (NIOSH, 1998).

Tennis Balls on Chair Legs in Classroom

25. Consider discontinuing the use of tennis balls on chairs to prevent latex dust generation.
26. Store cleaning products properly and out of reach of students.

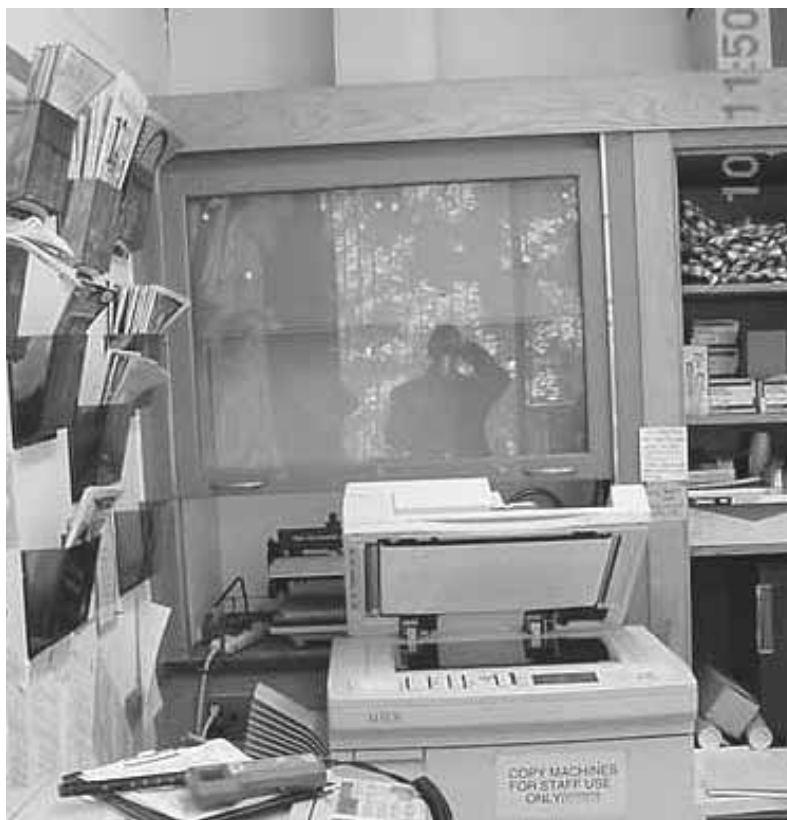
Picture 15

The faculty workroom had photocopiers and lamination machines. Lamination machines can produce irritating odors during use. VOCs and ozone can be produced by photocopiers, particularly if the equipment is older and in frequent use. Ozone is a respiratory irritant (Schmidt Etkin, 1992). The workroom is located in a former laboratory equipped with an exhaust hood (Picture 15). The exhaust hood was activated and was providing local exhaust ventilation to remove excess heat and odors from the room.

Lab Hood in Teachers Workroom

27. Remove lab hood in teacher's workroom and install ceiling mounted exhaust grill.
28. Use the principles of integrated pest management (IPM) to rid the building of pests. A copy of the IPM recommendations can be obtained from the Massachusetts Department of Food and Agriculture (MDFA) website at the following website:
http://www.state.ma.us/dfa/pesticides/publications/IPM_kit_for_bldg_mgrs.pdf.

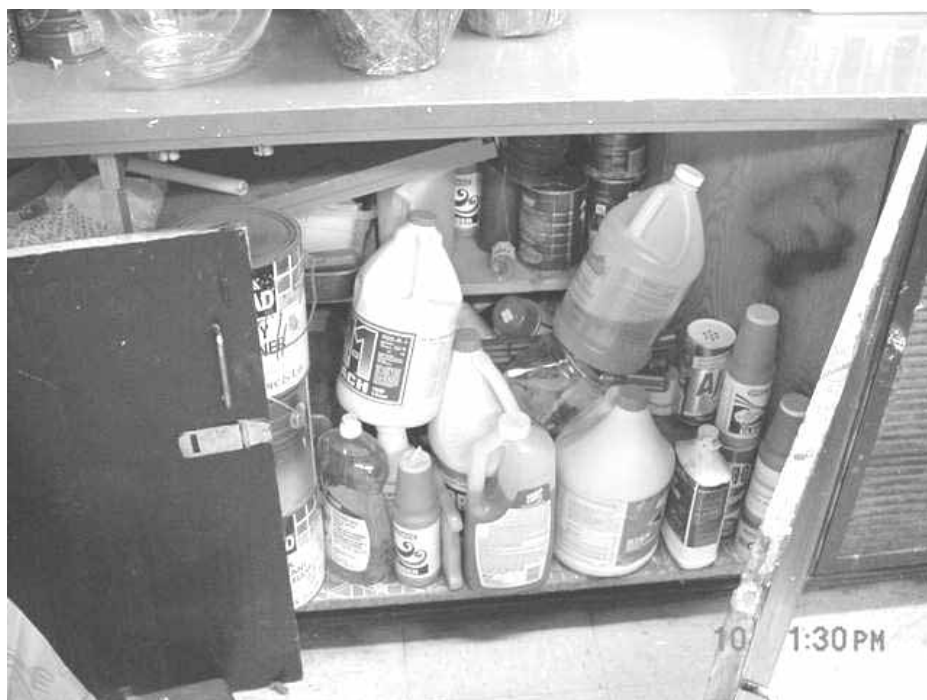
Picture 16

Finally, cleaning products were found on countertops and beneath sinks in a number of classrooms (Picture 16). Cleaning products contain chemicals, which can be irritating to the eyes, nose and throat.

Cleaning Products and Paint Stored Beneath Sink in Classroom
